**Clarence Valley Council
Draft Clarence River Wharves Development Plan
Volume 2 Site and Stakeholder Considerations**

August 2009

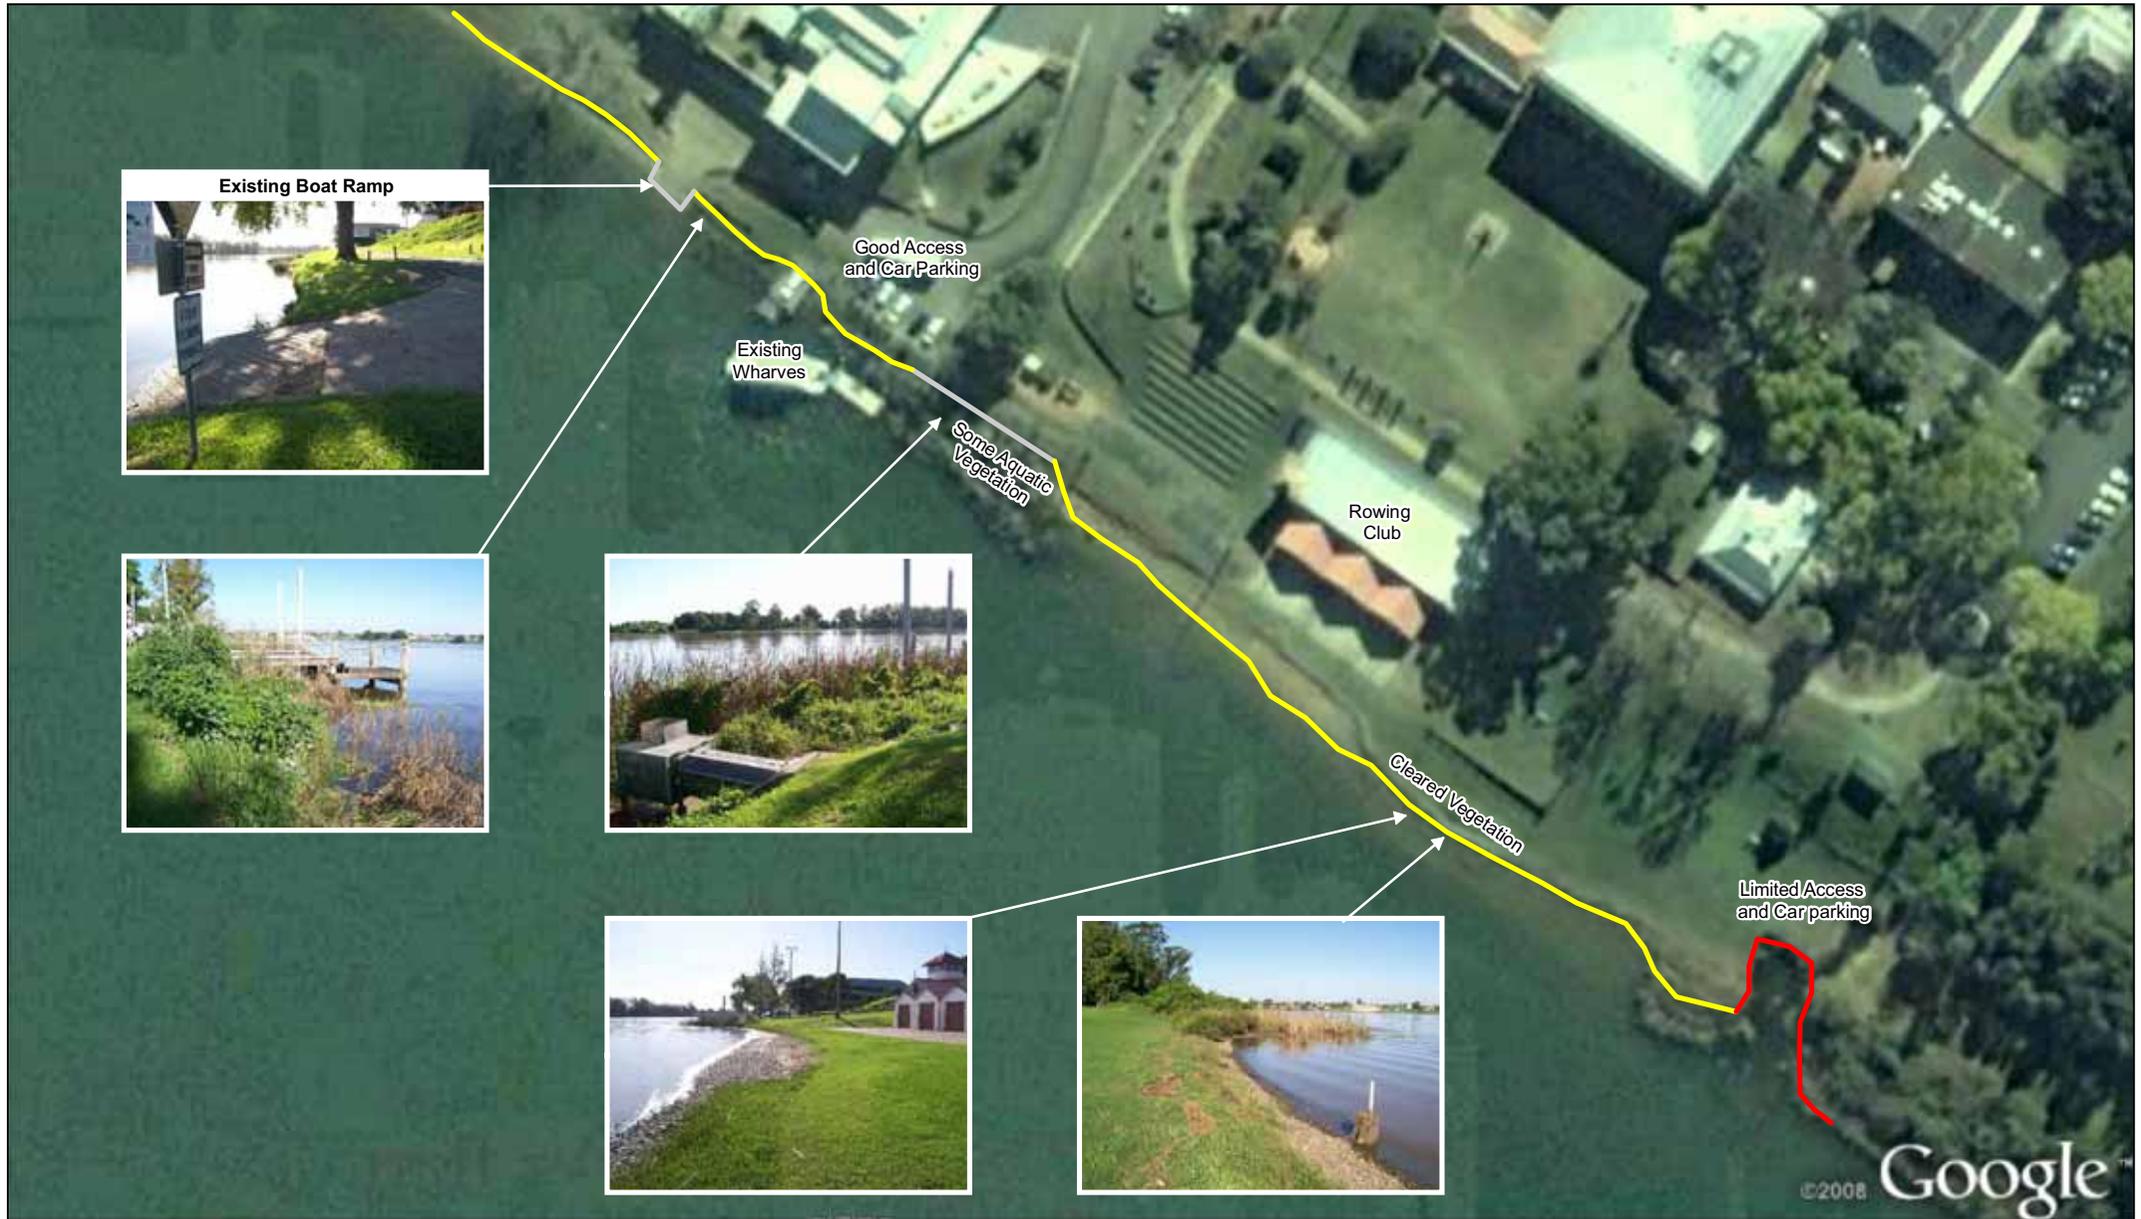
Bank Condition	
— Highly Active	(Red line)
— Minimally Active	(Yellow line)
— Stable - Artificial	(Grey line)

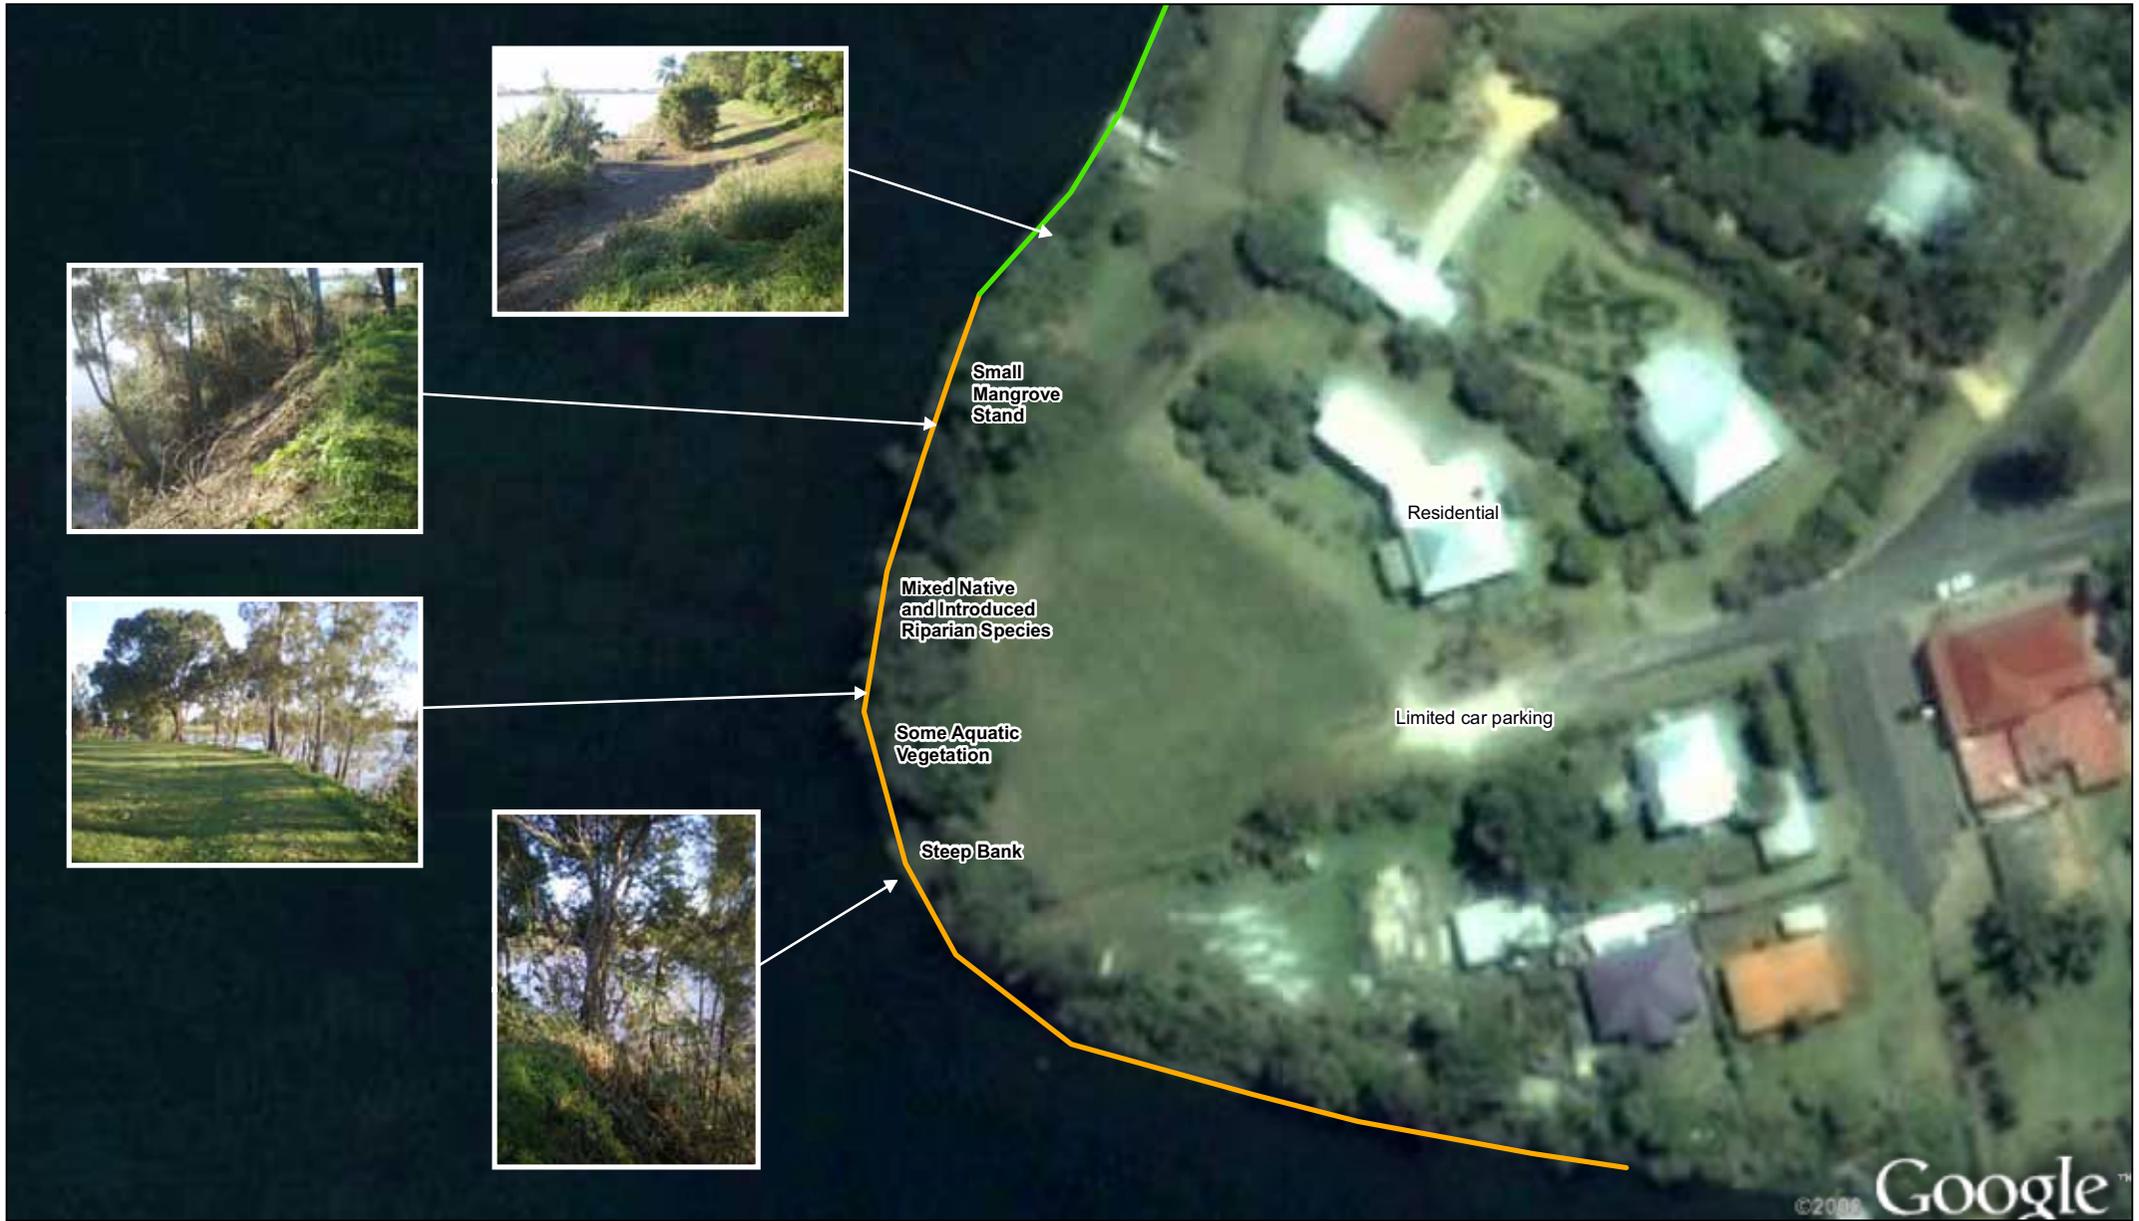
Figure 2-4

Bank Condition

- ▶ Brushgrove Site 2 where the site location at the apex of Woodford Island is exposed to the full force of flood flows. Evidence of soil attrition along the bank was observed as a result of the recent 2009 flood event. It is recommended that protective works along the lower bank will be required if this location is progressed; and
- ▶ Lawrence where the existing rock pitched protection is failing in locations, especially in the vicinity of the existing jetty. It is recommended that the stability of the current protection at the proposed pontoon location be reviewed at the time of detail design if this location is progressed.

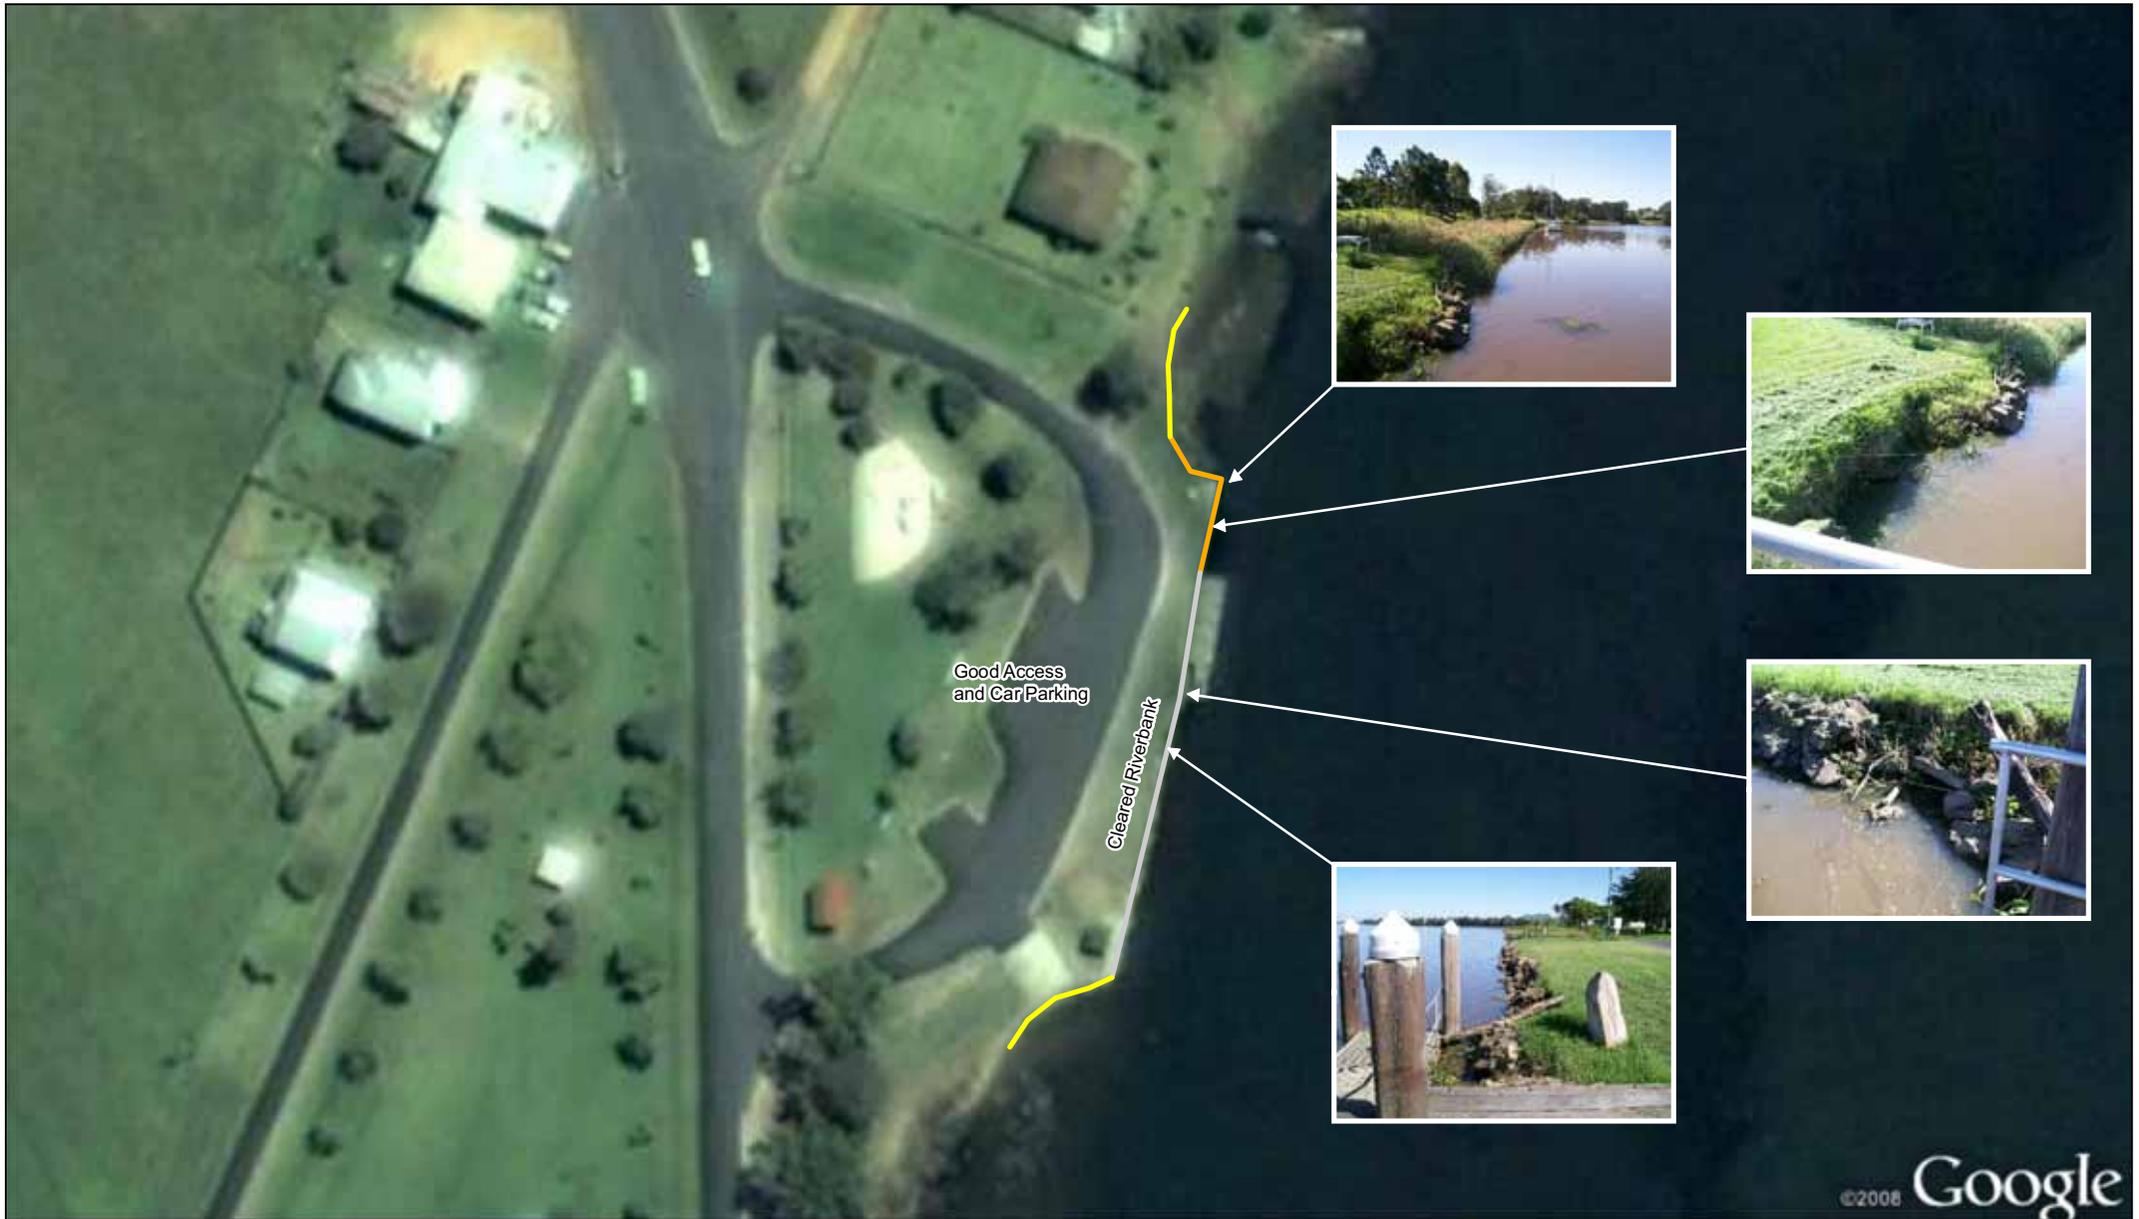
Figure 2-5

Item	Findings	Phot Ref.												
River Bank Stability	The entire lower bank in the vicinity of the existing pontoon is lined with large rock. The upper bank (levee) is grassed, graded and does not exhibit any signs of past erosion. The bank is artificially stable and the existing protection is in good condition	14 15												
Geotechnical	<p>The nearest sub-surface geotechnical data includes:</p> <ul style="list-style-type: none"> ▶ ‘Maclean Levee Investigation’ by Coffey Geosciences for Clarence River County Council in May / June 2002. We have only been provided with a site plan and logs, and the nearest borehole to the proposed wharf site is DCP 5 (Section 7), which comprised Dynamic Cone Penetrometer (DCP) tests to 1 m depth in fill. Further south near the Fisheries Department building (just south of Argyle St) is Borehole BH2 (collar RL 2.13 m AHD). This borehole intersected the following profile with respect to approximate river level: <ul style="list-style-type: none"> – Approx. 0 m AHD to –1.9 m AHD; Estuarine Sand – loose – medium dense (SPT values of N = 5) – Approx. –1.9 m AHD to –6.9 m AHD; Estuarine Clayey Sand – loose–medium dense (SPT values of N = 2) – Approx. –6.9 m AHD to –10.4 m AHD; Sandy Clay (Possibly Residual Soil, inferred stiff to very stiff consistency, with Pocket Penetrometer test results of 150 – 300 kPa and SPT values ranging from 6 to 14) <p>It is noted that the depth of the sloping riverbed in the vicinity of the proposed piling position is at approximately –3.0 m AHD.</p>													
Flooding	<table border="1"> <thead> <tr> <th>1/100 year flood level m AHD</th> <th>1/100 year water velocity m/s</th> <th>1/20 year flood level m AHD</th> <th>1/20 year water velocity m/s</th> <th>1/5 year flood level m AHD</th> <th>1/5 year water velocity m/s</th> </tr> </thead> <tbody> <tr> <td>3.8</td> <td>1.5</td> <td>3.3</td> <td>1.5</td> <td>2.5</td> <td>1.4</td> </tr> </tbody> </table>	1/100 year flood level m AHD	1/100 year water velocity m/s	1/20 year flood level m AHD	1/20 year water velocity m/s	1/5 year flood level m AHD	1/5 year water velocity m/s	3.8	1.5	3.3	1.5	2.5	1.4	
1/100 year flood level m AHD	1/100 year water velocity m/s	1/20 year flood level m AHD	1/20 year water velocity m/s	1/5 year flood level m AHD	1/5 year water velocity m/s									
3.8	1.5	3.3	1.5	2.5	1.4									
Ecology	The occasional <i>casuarina</i> sp. exists on the riverbank adjacent to the existing wharf. The weed morning glory is also present.	16

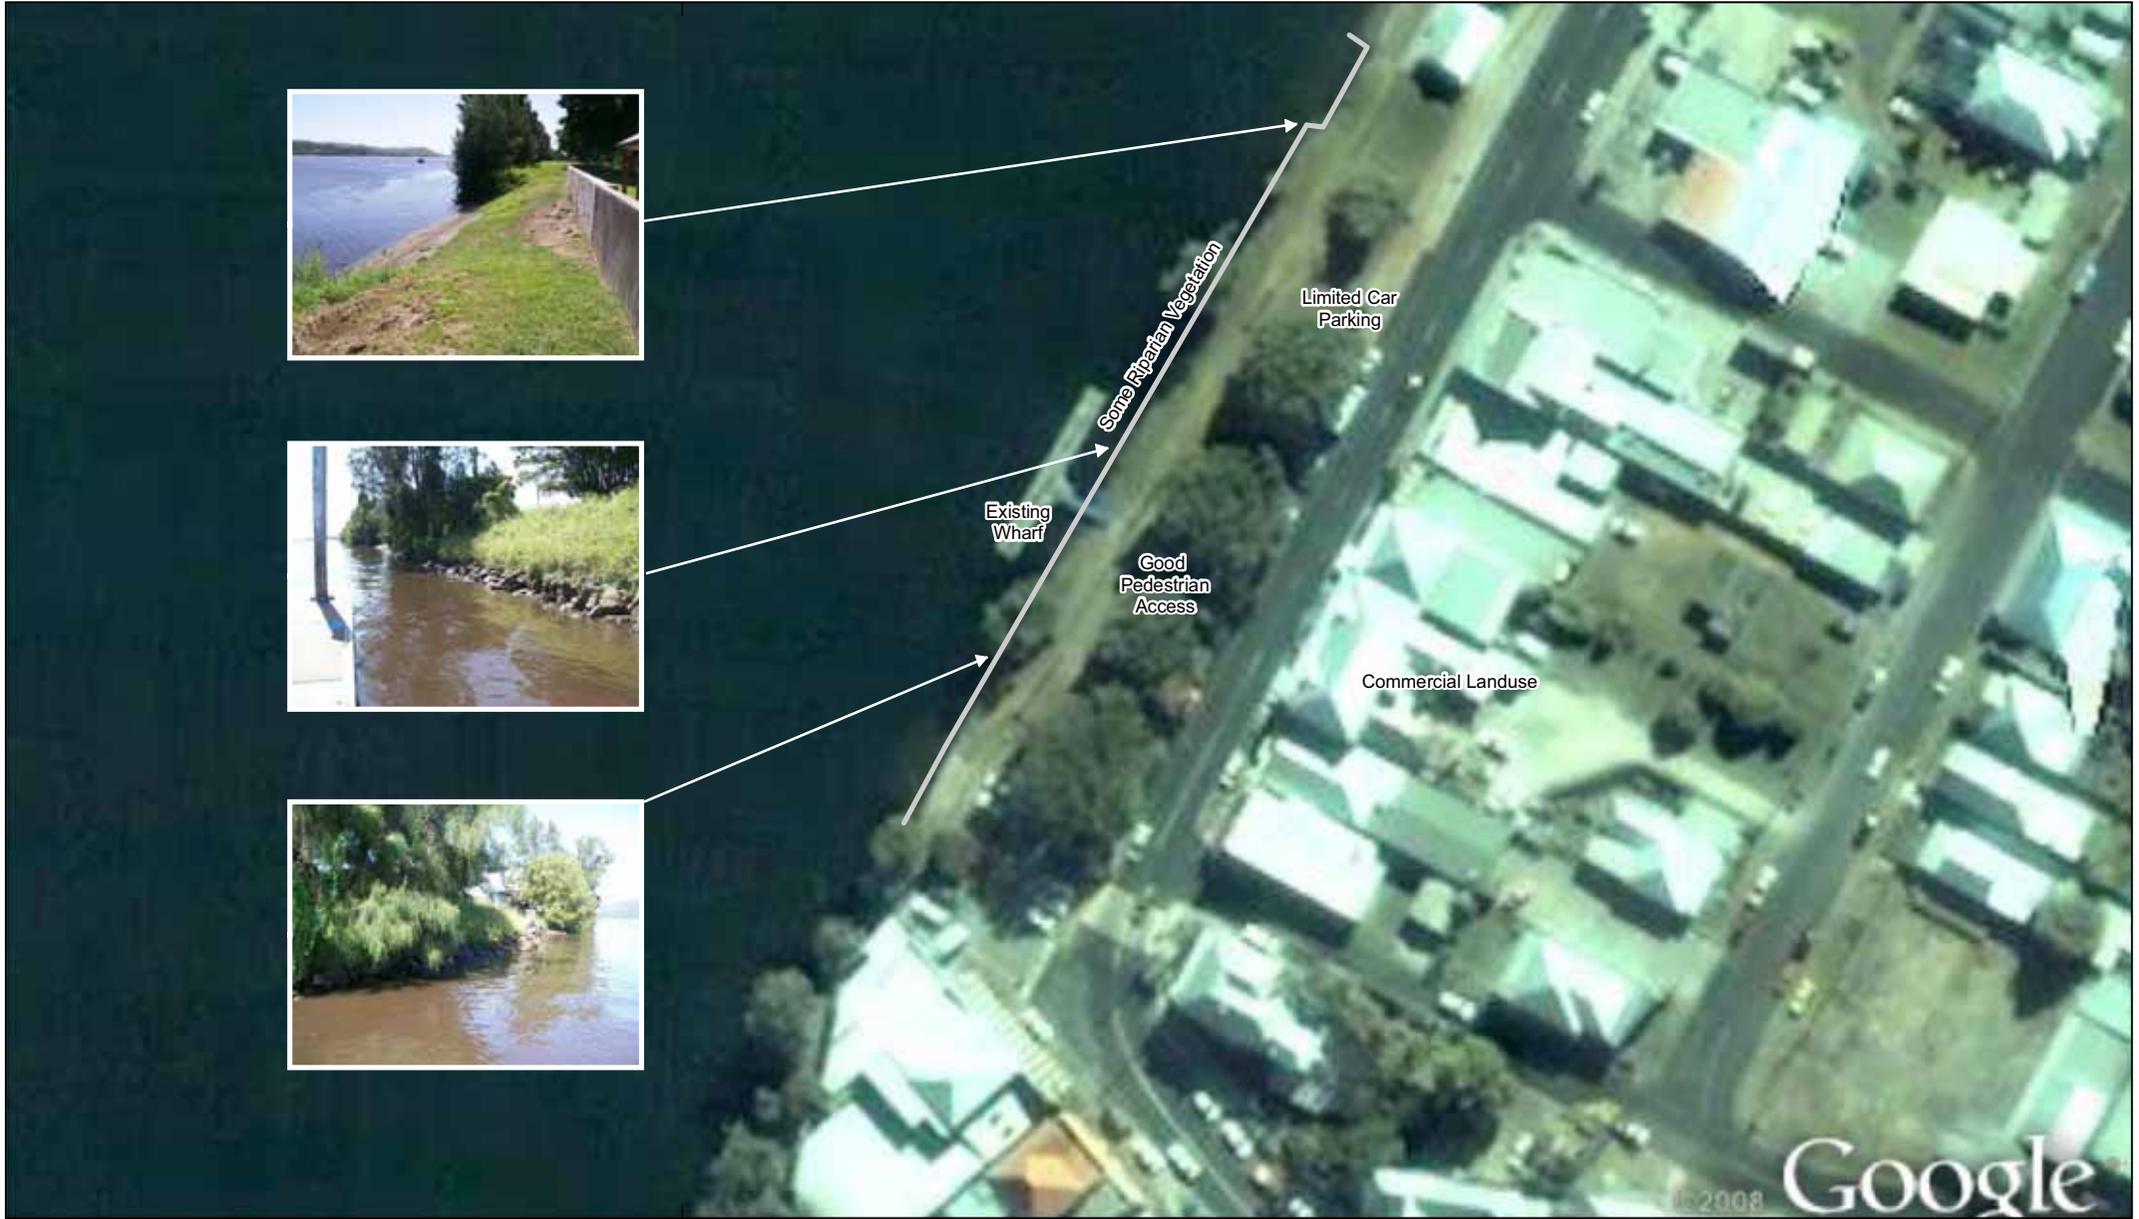
Figure 2-6

Ecology	A fringing row of grey and river mangroves exists along the riverbank adjacent to the existing wharf. Some casuarina sp. are also growing on the river bank in this location. Upstream of the existing boat ramp there is the occasional mangrove but the area is dominated by <i>phragmites australis</i> . Any impact on the mangroves will require approval by DPI-Fisheries under the Fisheries Management Act. It is therefore recommended that any structure/works are located upriver of the boat ramp.	21 22
---------	--	----------

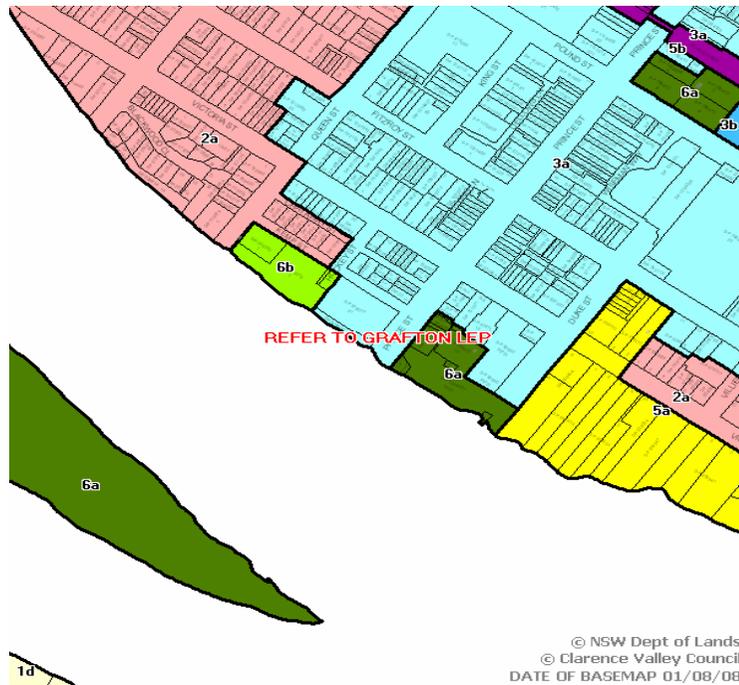
Figure 3-1 Grafton Zoning

The preferred site in Grafton spans two zones being Zone No 3 (a) (Business Zone) and Zone No 6 (a) (Public Recreation Zone) – refer Figure 3-1.

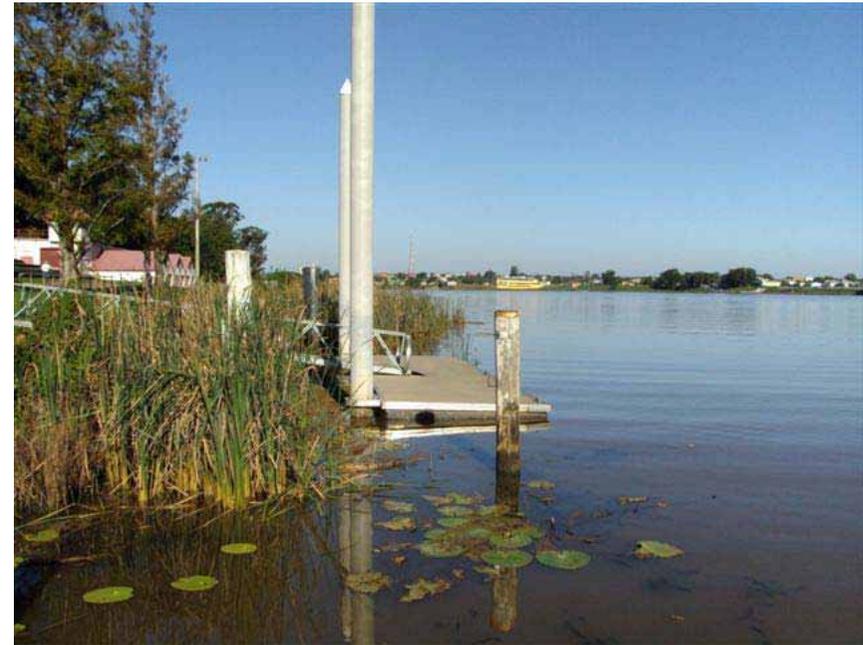
Photograph B 3

Item	Findings	Photo Ref.
Dimensions	level. 2 no. 400mm dia. painted steel piles in galv. steel guides at landward rear corners. 10m long galv. steel gangway. 3 no. tie-ups	2
Approximate Age	10 years	
Anomalies/Defects	Damaged pile paint system within tidal zone. 2 no. broken tie-ups.	3 4

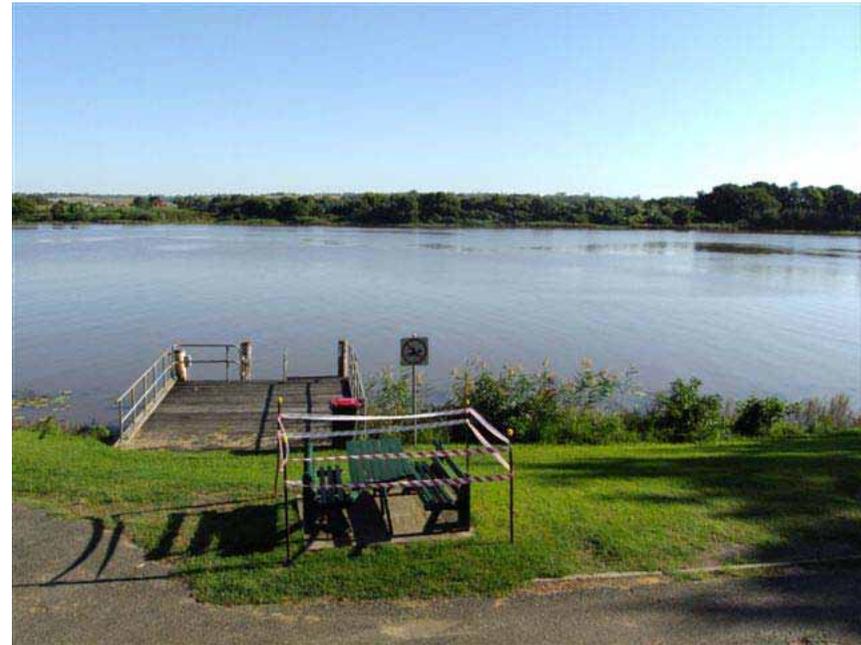
Photograph B 7

Item	Findings	Photo Ref.
Description and Approximate Dimensions	Fixed timber 5.4m x 10.6m wharf. Front 3.4m x 3.2m section set 400 mm lower than top level. Galv. steel handrailing at sides. Potable and (lockable) electricity source.	5, 6
Approximate Age	> 20 years	
Anomalies/Defects	Heavily weathered and split decking,	7, 8, 9, 10,

Therefore, assuming that appropriate maintenance and/or repairs are undertaken, all structures with the exception of Grafton timber wharf are considered suitable for augmentation works. The structural capacity to withstand any additional loading will to be confirmed beforehand via calculation.

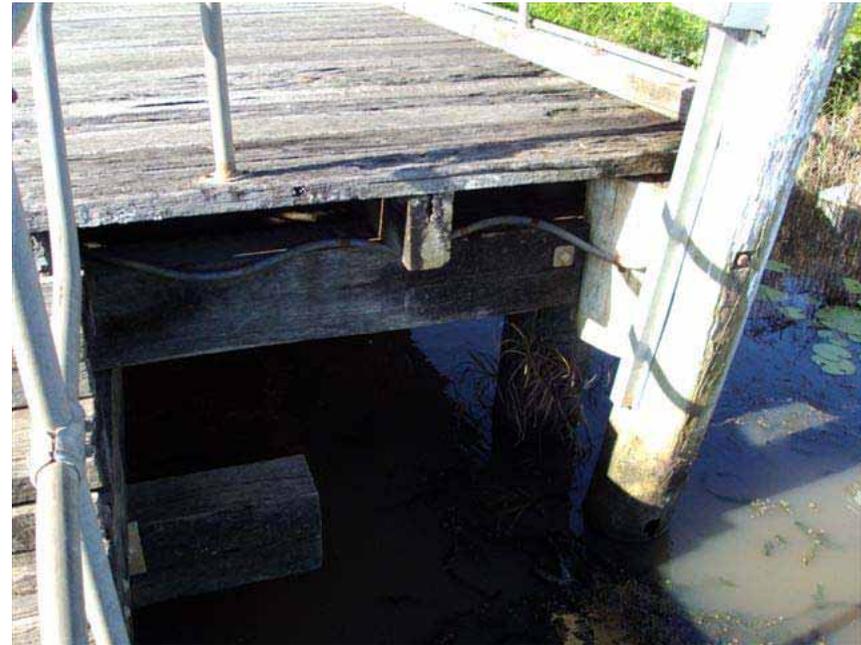
Photograph B 11

Item	Findings	Photo Ref.
	joists, bearers and piers. Several trip hazards.	11
	Corroded handrail – non-continuous in sections.	12, 13
	Corroded fixings within tidal zone.	14

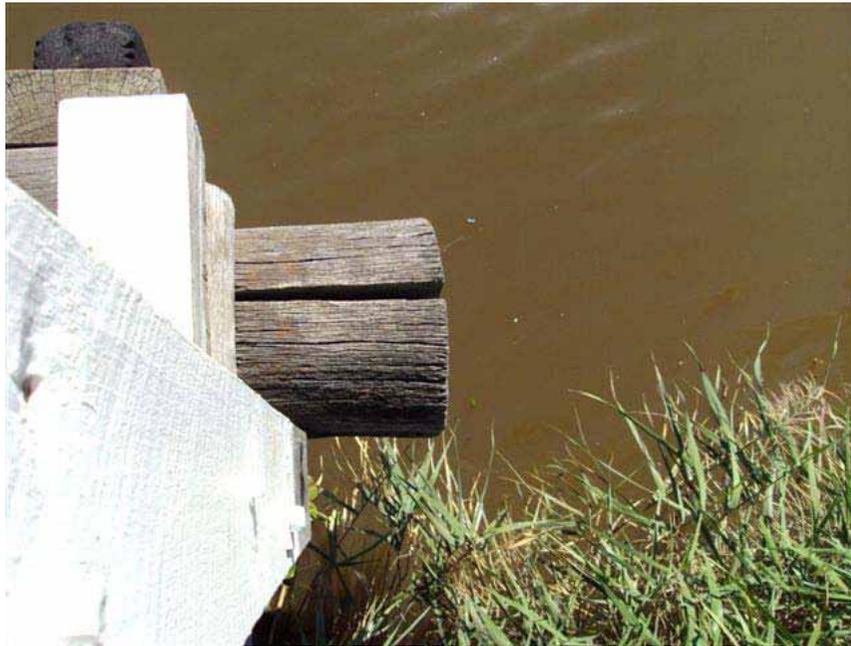
Photograph B 18

Item	Findings	Photo Ref.
	Significant spalling to tops of concrete piers.	16
	Minor corrosion to fixings in tidal zone.	18
	Minor splitting to decking timbers	19
	Stair overrun too short - unsafe	20

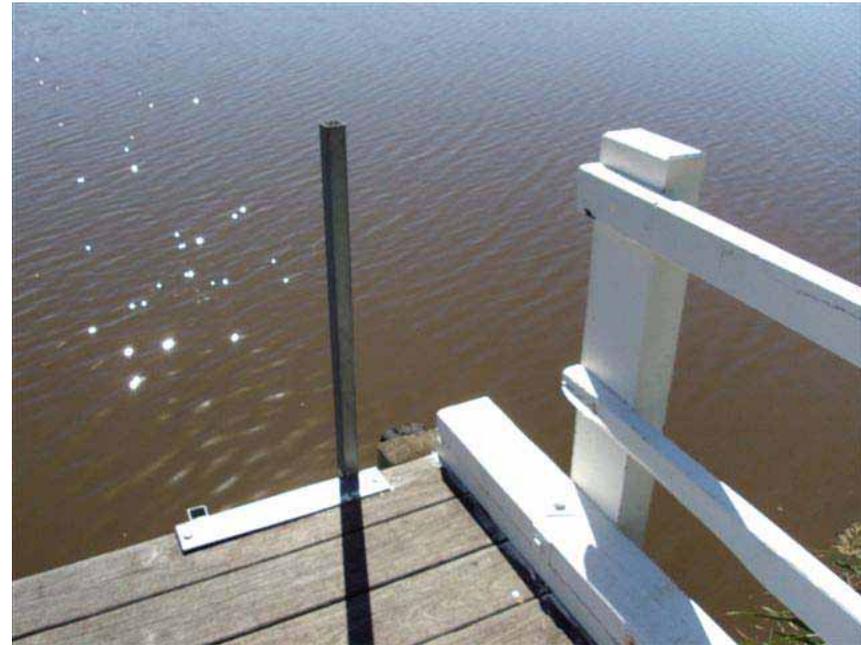
Photograph B 21

Item	Findings	Photo Ref.
Description and Approximate Dimensions	Fixed timber 12.4 m x 4.8 m wharf with additional 5 m x 1.7 m steel side section 400 mm lower than top level. 8 no. 400 mm dia. timber piles. Galv. steel handrail to downstream side of main wharf and landward side of lower section.	21, 22
Approximate Age	15 years	
Anomalies/Defects	Minor surface corrosion to handrail baseplate.	23

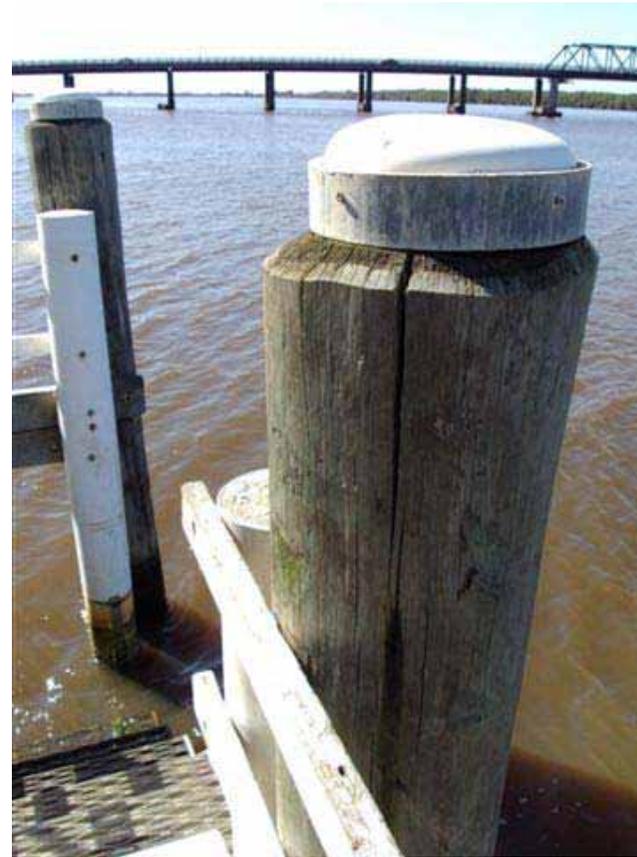
Photograph B 38

Item	Findings	Photo Ref.
Description and Approximate Dimensions	Floating concrete-topped pontoon.	38
	2 no. reinforced concrete piles in steel guides at sides near landward edge.	
	4 no. timber fender piles at seaward face.	39
	Galv. steel gangway.	
	4 no. tie-ups.	
Approximate Age	5 years	
Anomalies/Defects	Minor shrinkage cracking to concrete deck.	40
	Minor cracking to timber fender piles.	41

The pontoons at Grafton, Maclean and Yamba and timber structure at Lawrence appear to be in good condition and require only minimal maintenance to correct the issues noted.
